Manhole Inspection Summary

Manhole # S37Y1_007MH

Location Address: **E. Garrett St. (Behind 304 Washburn Ave.)** Cross Street: **4th St.**

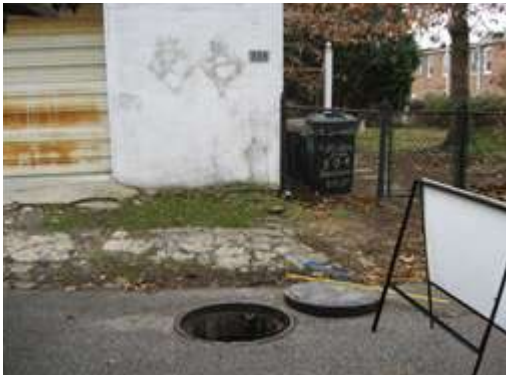
Location View

Garrett-304 Washburn

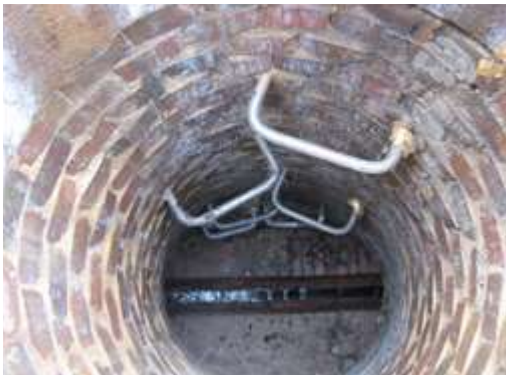
Steps Count: **6** Missing: **0** ☒ **Corroded**

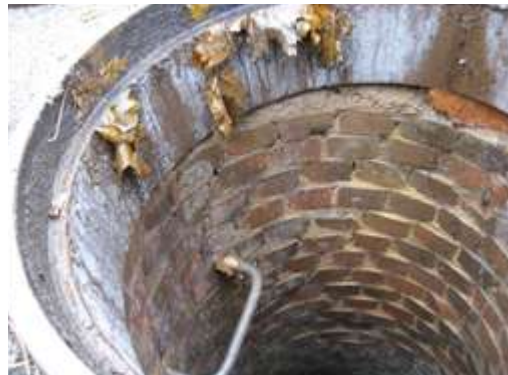
Defect 1

Chimney / Frame Adjustment ☒ Exists Material: **Brick** ☐ Parged Height: **6** (in.)
Condition: ☐ Sound ☒ **Cracked** ☐ Root Intrusion ☒ **Loose Brick** ☒ **Deteriorated**
Infiltration: ☐ None ☒ **Joint** ☒ **Cracks** ☐ Mortar ☐ Roots ☐ Wall

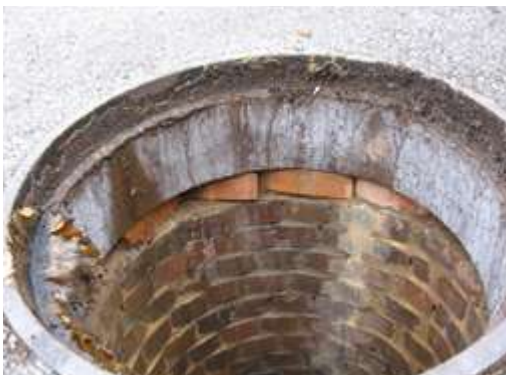
Defect 2

Barrel Material: **Brick** ☐ Parged
Shape: **Circular** Diameter: **42** (in.) Length: (in.)
Condition: ☐ Sound ☒ **Cracked** ☐ Root Intrusion ☐ Loose Brick ☐ Deteriorated
Infiltration: ☐ None ☐ Joint ☒ **Cracks** ☐ Mortar ☐ Roots ☒ **Wall**

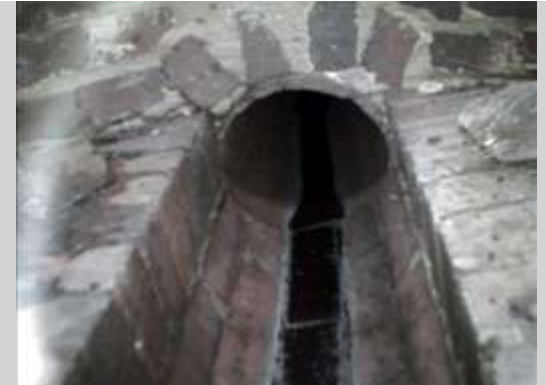
12 O'Clock Outflow

8 in. Circular Gravity Sewer
Pipe Out @ 12 O'Clock

Pipe Height: **10.8** (in.) Rod and Bar (Angled)
Pipe Material: **Clay** ☐ Pipe Lined
Invert Depth: **9.90** (ft.) Flow Characteristics: **Fast**
Deposits: ☒ None ☐ Mud ☐ Sludge ☐ Debris ☐ Grease
Silt Depth: (in.) Deposits Extent:
Infiltration: **None** Pipe Seal Cond: **Sound**

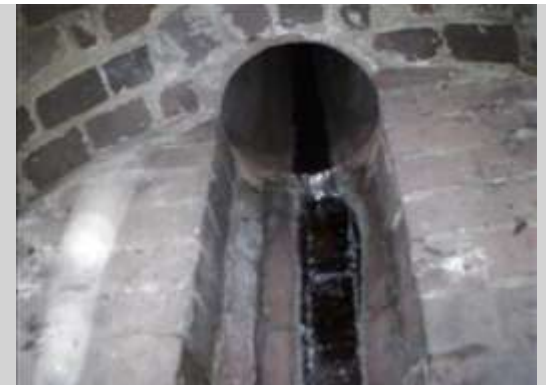
6 O'Clock Inflow

8 in. Circular Gravity Sewer
Pipe In @ 6 O'Clock

Pipe Height: **9.6** (in.) Rod and Bar (Angled)
Pipe Material: **Clay** ☐ Pipe Lined
Invert Depth: **9.06** (ft.) Flow Characteristics: **Fast**
Deposits: ☒ None ☐ Mud ☐ Sludge ☐ Debris ☐ Grease
Silt Depth: (in.) Deposits Extent:
Infiltration: **None** Pipe Seal Cond: **Sound**
